# historic structure report

## CAPE COD

THREE SISTERS LIGHTHOUSES

HISTORIC STRUCTURE REPORT  
THREE SISTERS LIGHTHOUSES  
CAPE COD NATIONAL SEASHORE  
MASSACHUSETTS

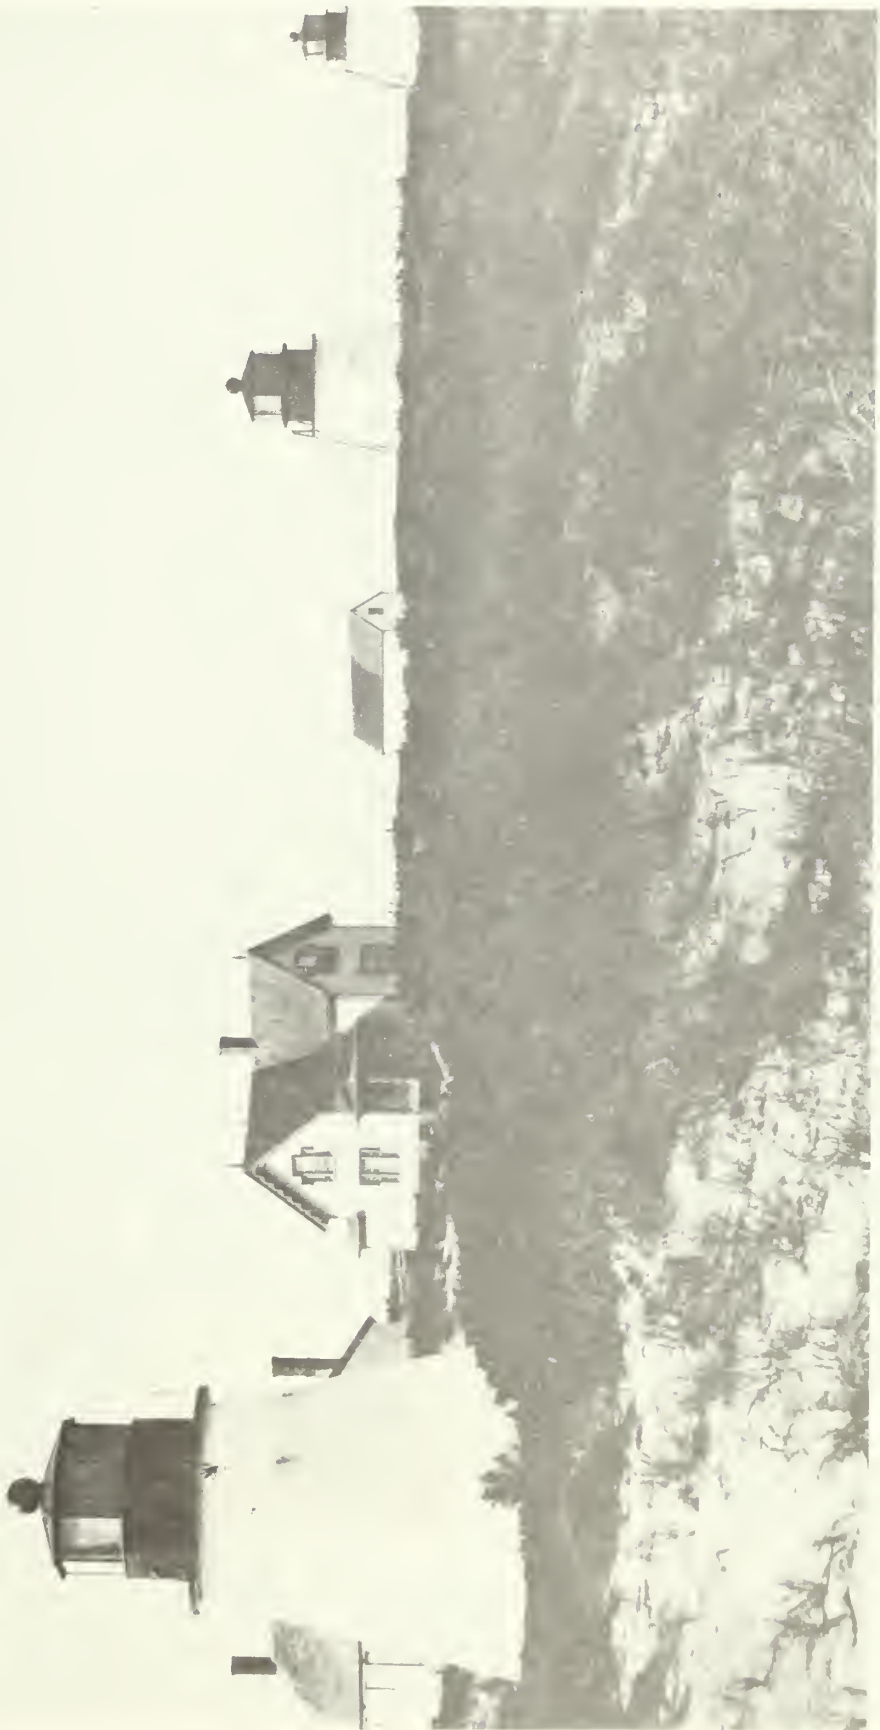
Figure 2

The Original Masonry "Three Sisters"  
Courtesy of the National Archives, Washington, D.C.  
View from southeast, 1875/1892

In the background one can see the 1838 brick house and the 1875 wood frame dwelling. The use of the term "three sisters" was never an official name for the lighthouse. According to Edward Rowe Snow in his book, Famous New England Lighthouses, they were named the "three sisters of Nauset" soon after their construction, but he does not indicate whether the local population or mariners gave them that designation.

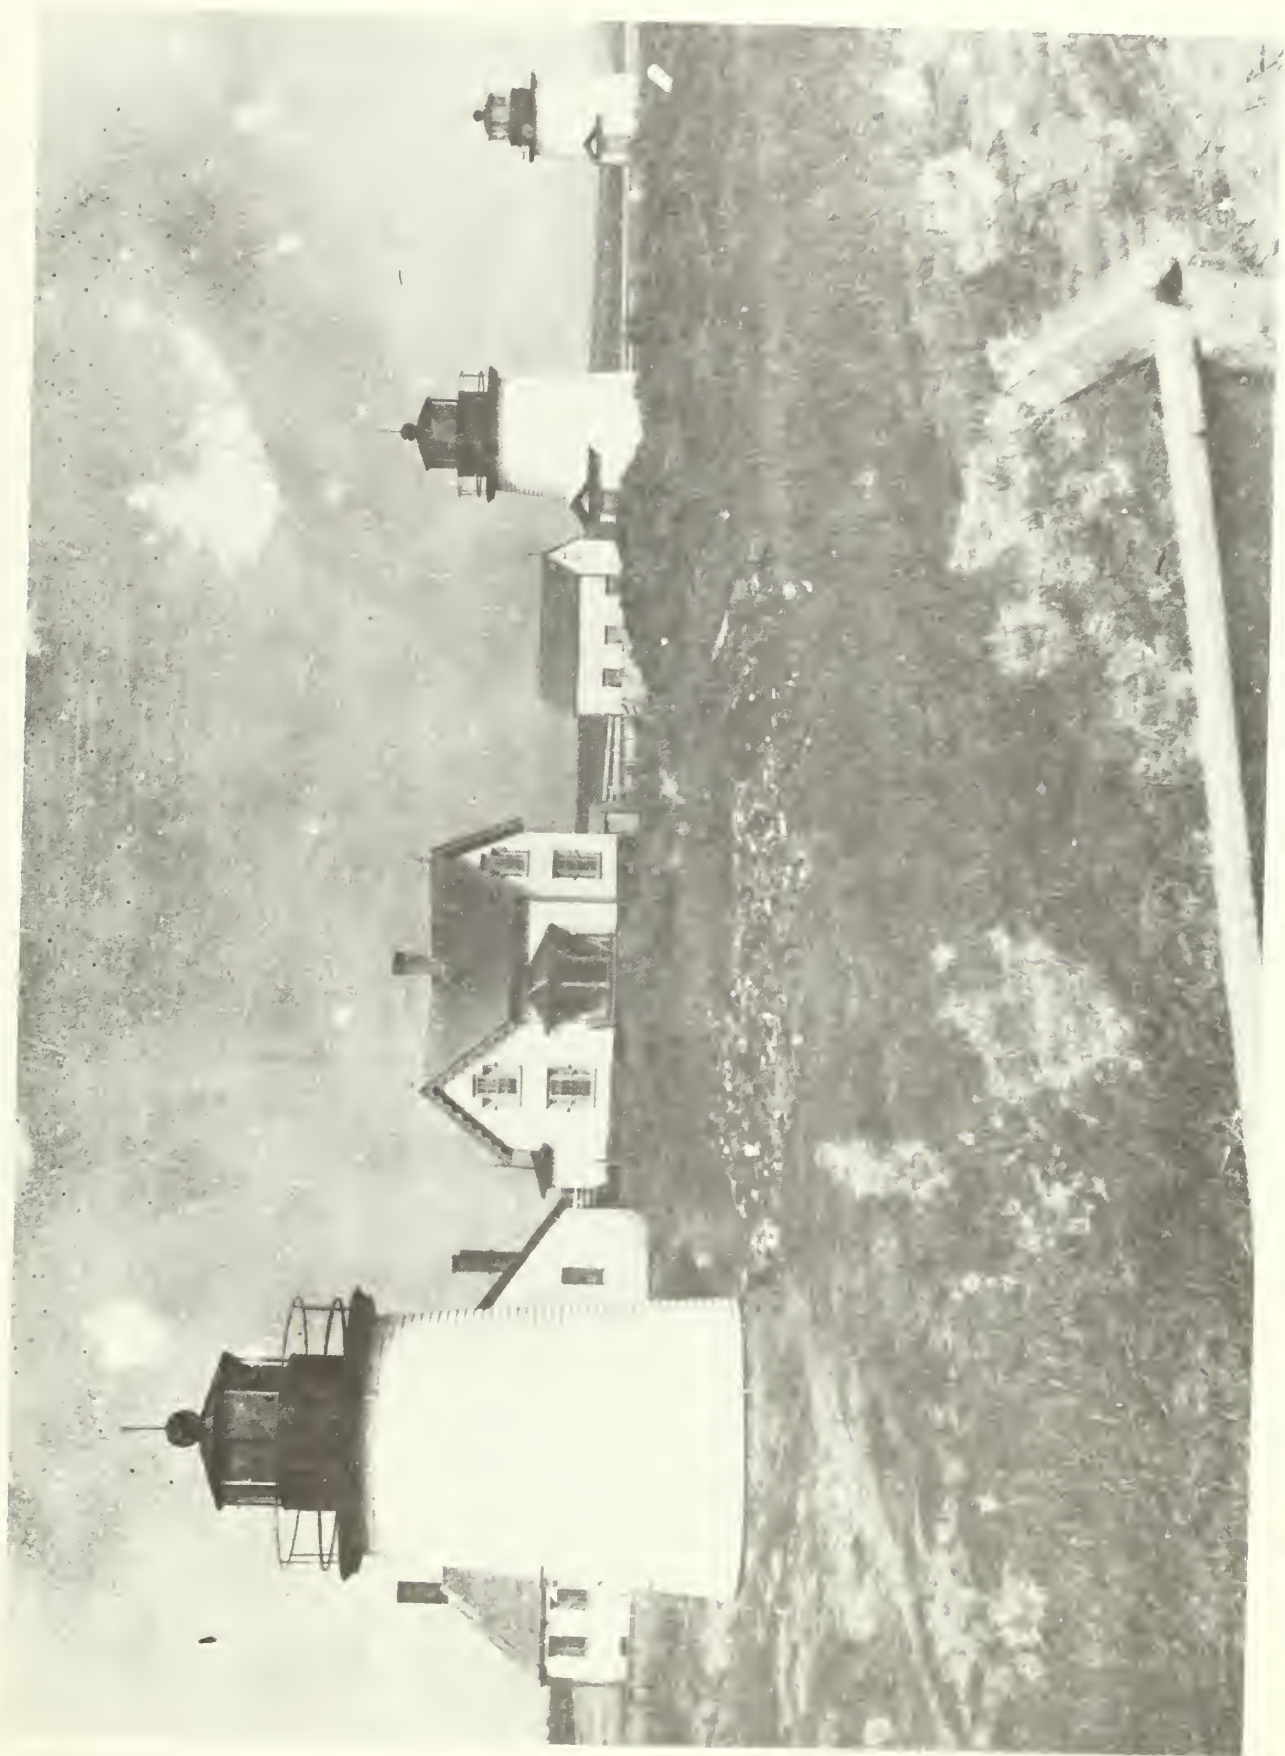
Figure 3

The 1892 Wooden "Three Sisters"  
Courtesy of Cape Cod National Seashore  
View from southeast, 1895-1911

The storm doors attached to the entrances in 1895 are visible on two of the lighthouses.

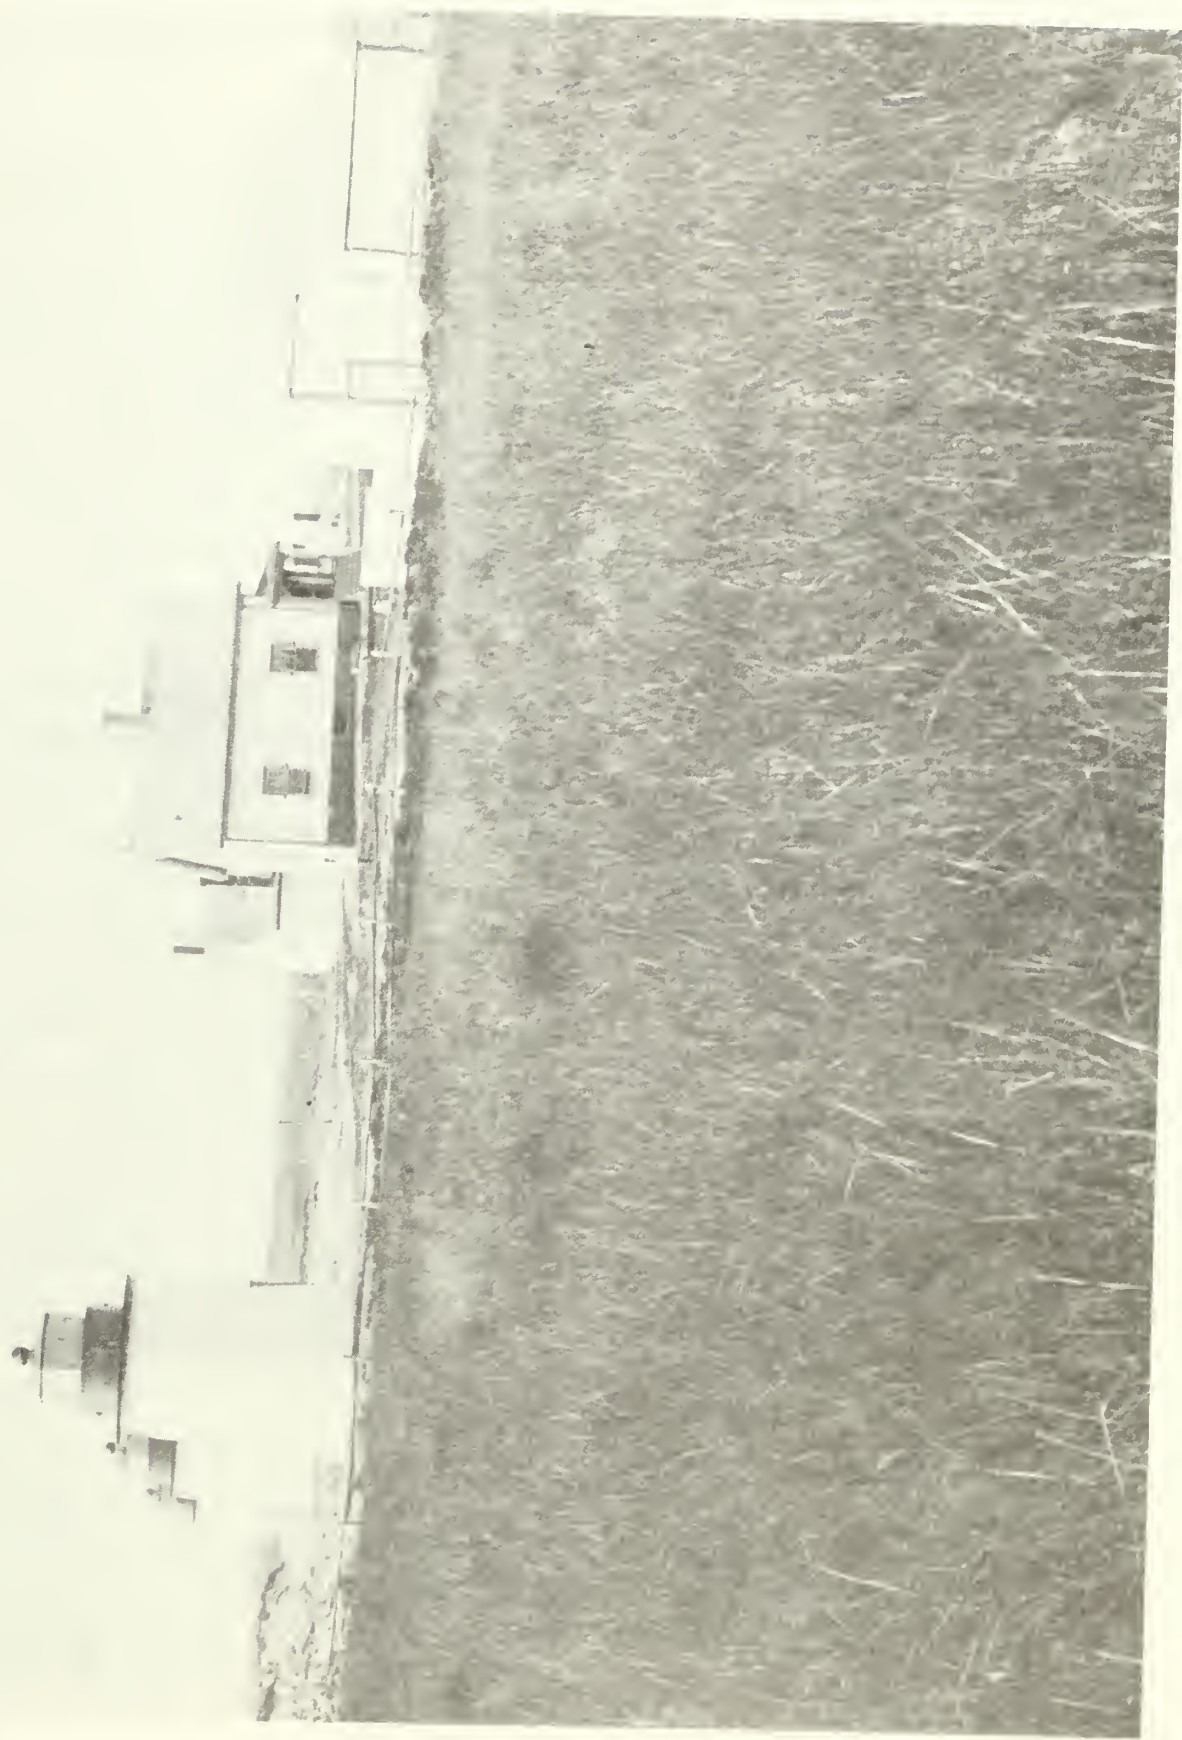
Figure 4

The 1892 Wooden "Three Sisters"  
Courtesy of the National Archives, Washington, D.C.  
View from north, 1892-1921

The building in the background between the frame keeper's residence and the barn appears to be the French Cable Station which burned May 3, 1901.\* The Cable Station building was sold and converted to use as a hotel in 1893 after the French Cable Company operations were moved to Orleans in 1891. Because of the photographer's viewpoint, the building cannot be the Cable Company's stable which is shown on map 2.

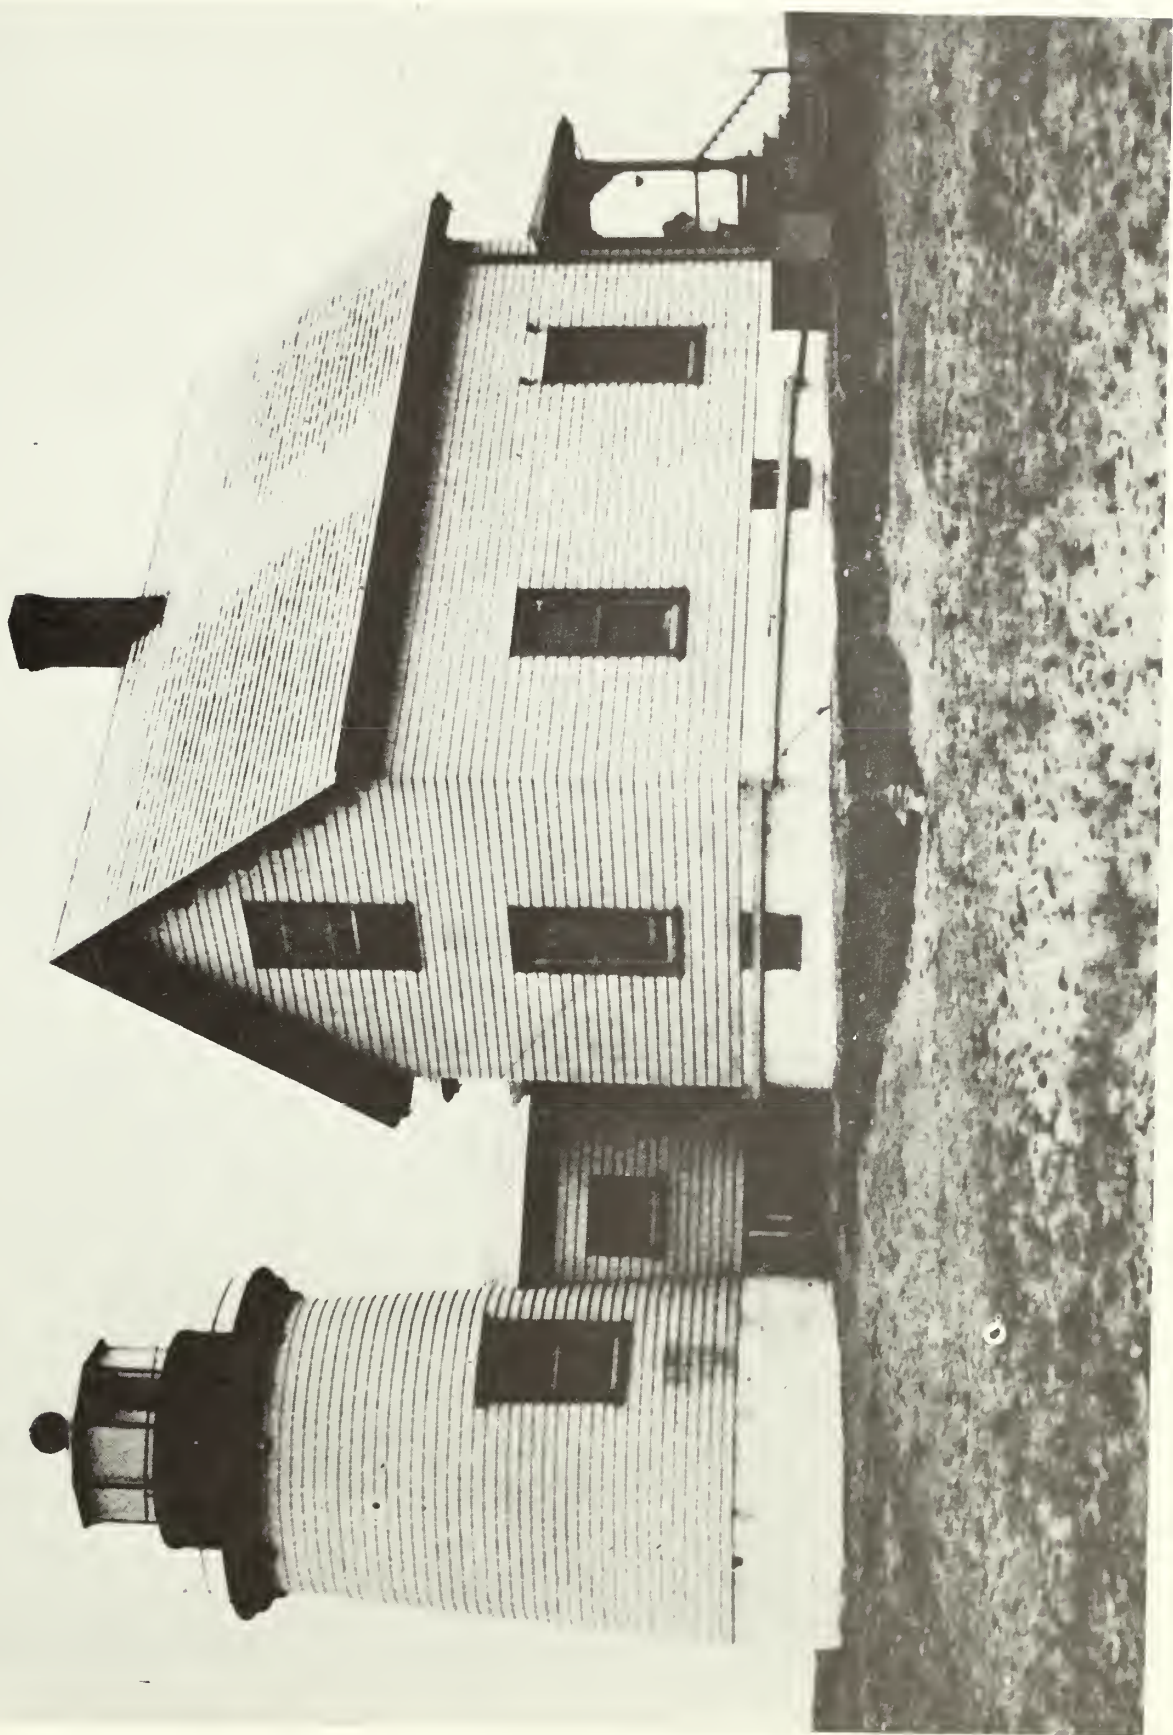
Within days after the single light began to function, the second district inspector reported that the tower was so poorly constructed that, despite its low height, even moderate winds caused it to vibrate. The shaking interfered with the flashing apparatus. The inspector asked permission to install four galvanized guy wires as a means of stabilizing the tower. The guy wires are visible in Figure 5.<sup>28</sup>

The Wooden Central Tower Attached to the 1875  
Wood Frame Keeper's Dwelling  
Courtesy of the National Archives, Washington, D.C.  
View from northeast

This May 1915 photograph shows the original tower window which was identical to the ones in the other two lights. Guy wires placed on the tower in 1911 to stabilize it are also visible as well as the connection to the 1875 wood frame keeper's dwelling.

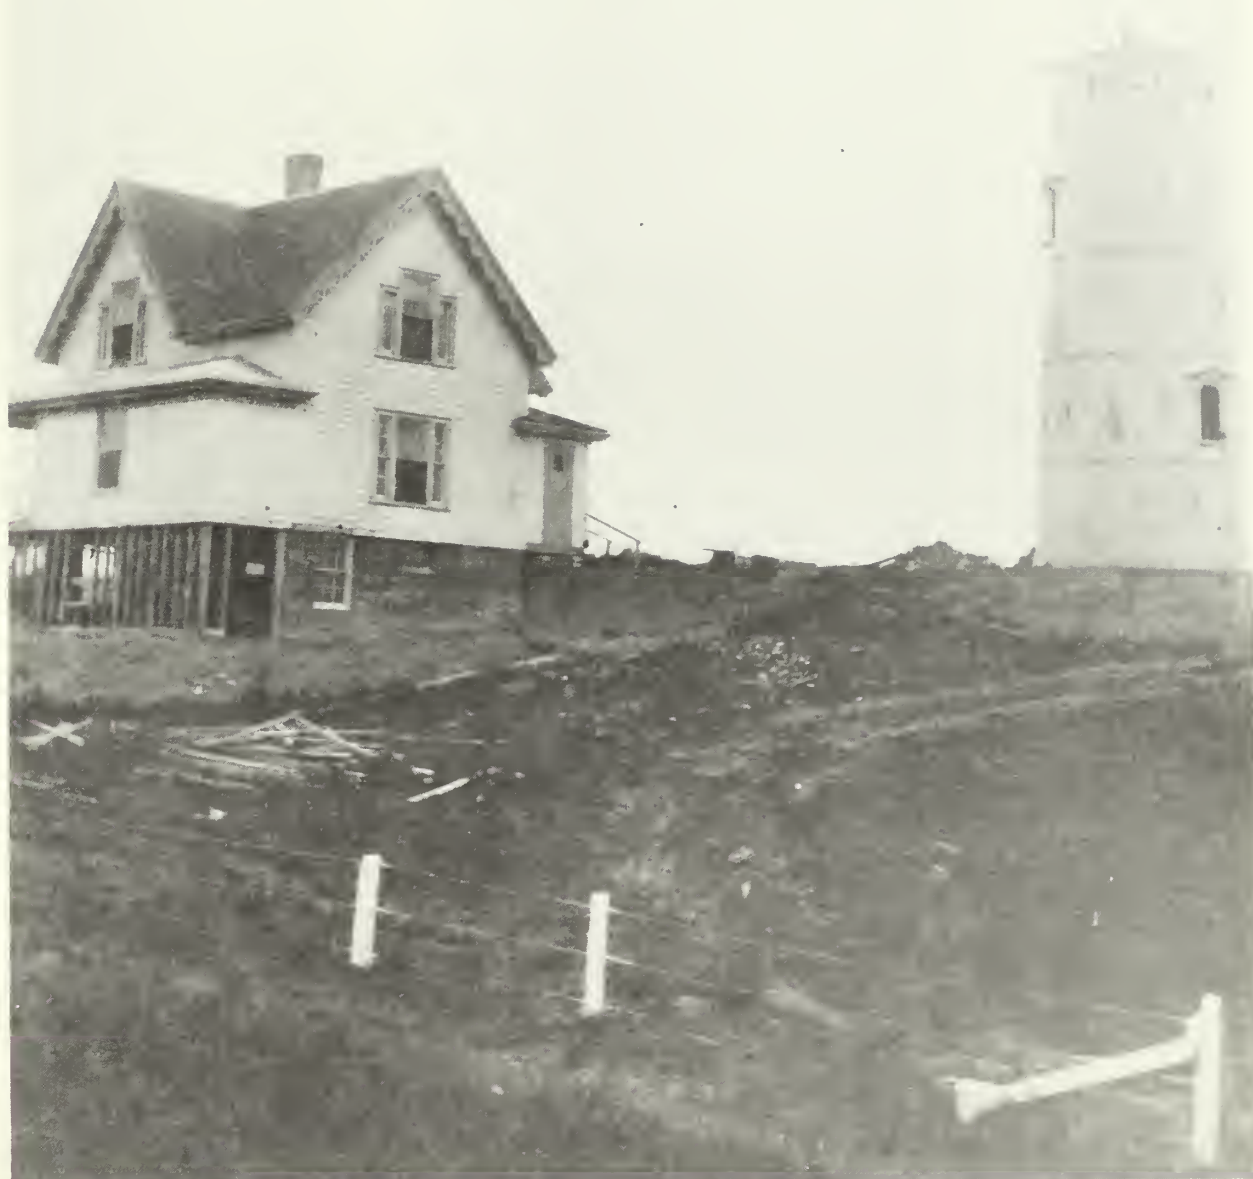
Figure 6

Installation of the Cast-Iron, Unused Chatham Tower  
Courtesy of the National Archives, Washington, D.C.  
View from southwest, 1923

In addition to the cast-iron tower, the 1875 wood frame keeper's dwelling can be seen on its new location over a new cellar. This photograph of the 1875 structure was taken on the opposite side of the house from that shown in Figure 5 and, therefore, accounts for the different appearance.

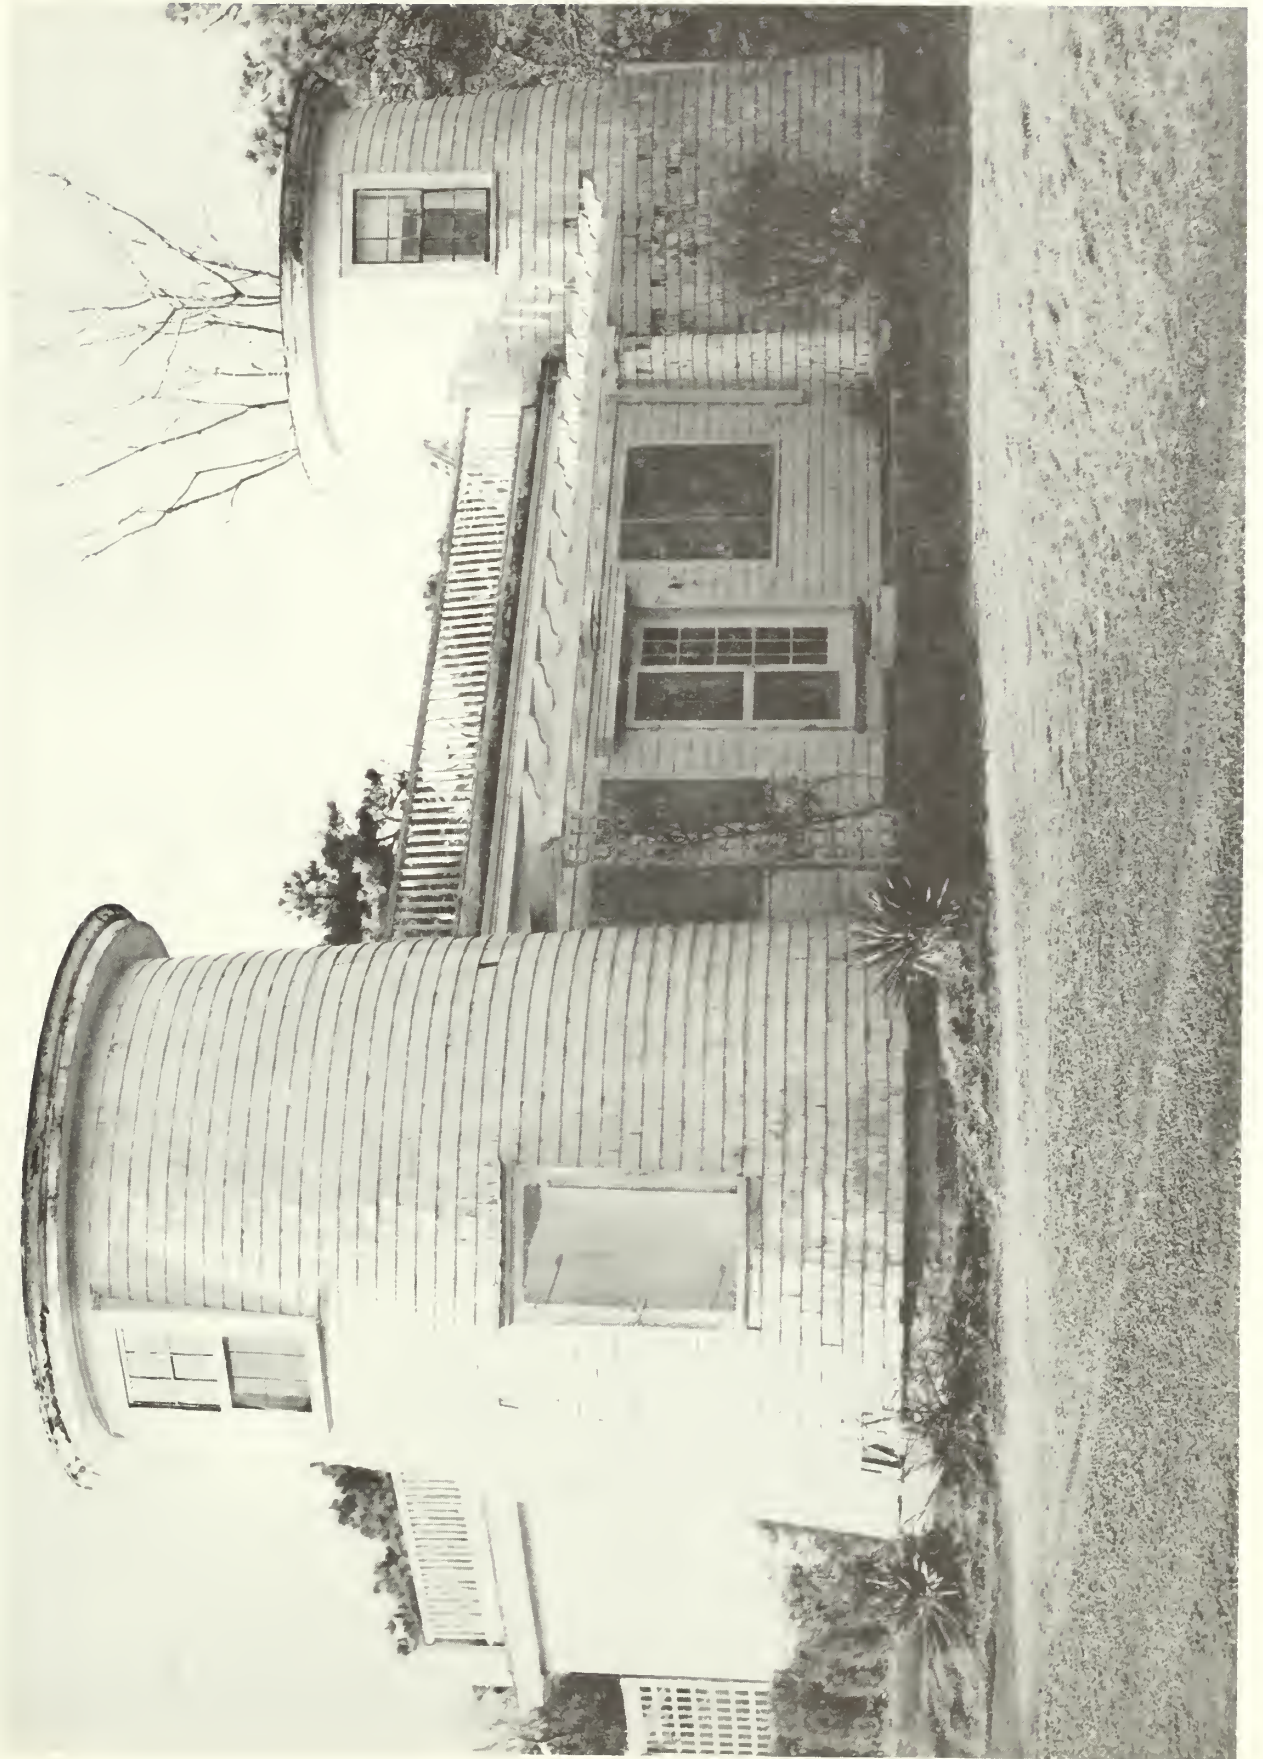
Figure 7

"The Twins" and attached cottage  
Courtesy of Cape Cod National Seashore  
View from southeast, 1976  
Photograph by Swan

The Cummings' cottage incorporated the North Twin (right) and the South Twin (left).

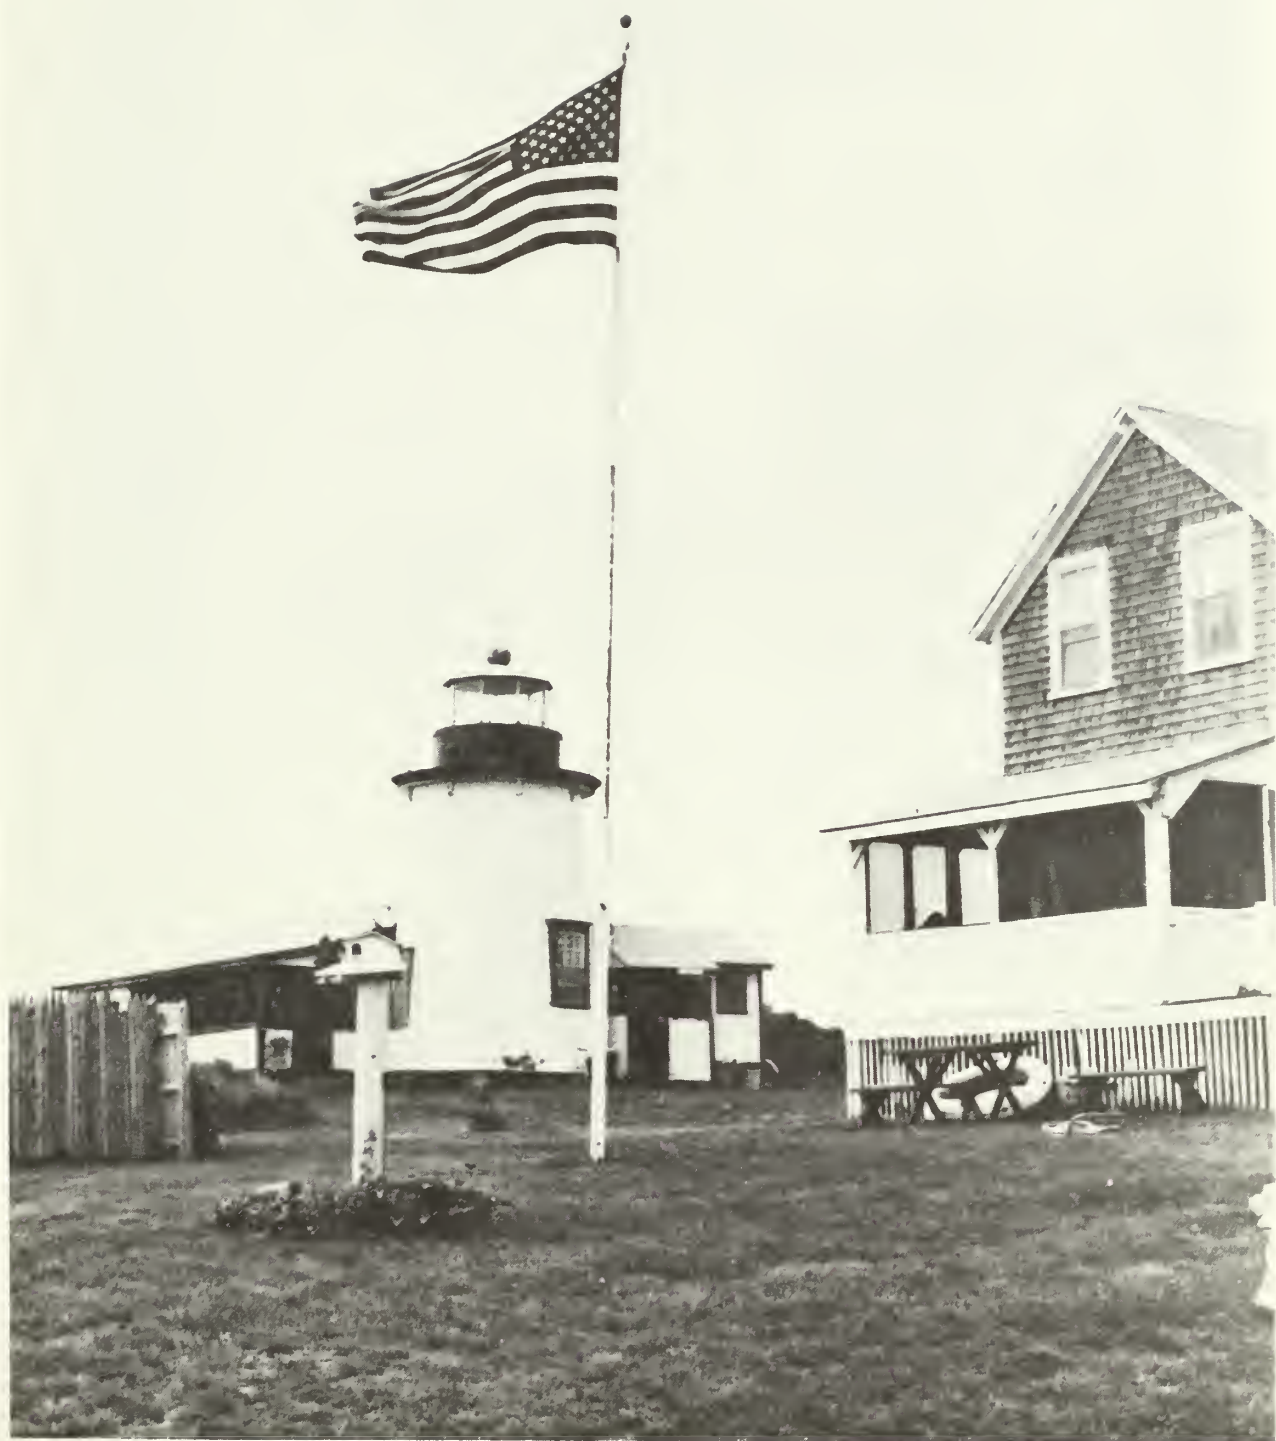
Figure 8

The Beacon Cottage  
Courtesy of Cape Cod National Seashore  
View from northeast, July 1973  
Photograph by Swan

The Hall family converted the Beacon into a cottage by adding wings to the west and south.

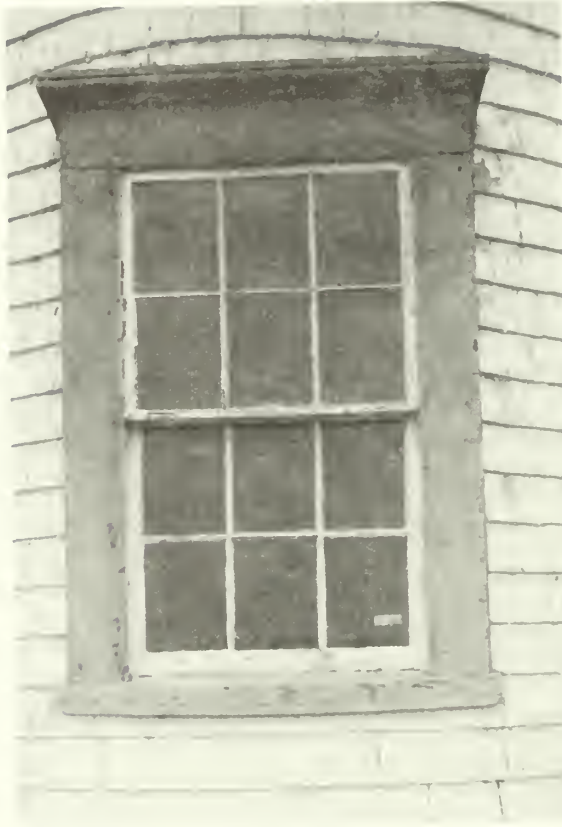
Figure 10

The three towers have three windows each--two at the first floor and one at the second. Only one window at the first floor of each tower is original (see Figure 10). The evidence for this conclusion is drawn from Figures 3 and 4, paint layering (see Appendix D), and moulding profiles (see Sheet 6). The original windows in the Beacon and the North Twin are to the left of the door. In the South Twin, the original window is to the right of the door. An examination of the historic photographs for window/door relationships shows that the North and South Twins were originally in the north and south positions, respectively, of the Three Sisters and the Beacon was the central tower. The original windows are six-over-six single-hung sash with sash openings of 2 feet-7 inches wide and 4 feet-4 $\frac{1}{4}$  inches high. The nonhistoric windows in the Beacon are two-over-two single-hung sash with 2 feet-3- $\frac{3}{4}$  inches wide and 4 feet-5 $\frac{1}{2}$  inches high sash openings. The nonhistoric windows in the North and South Twins are six-over-six single-hung sash with 2 feet-6 $\frac{1}{2}$  inches wide and 4 feet-4 inches high sash openings. There is no firm documentary evidence to date the non-historic windows. The fact that the later windows on the Twins match each other but differ from those on the Beacon strongly suggests that they were installed by the private owners. The most logical time for the private owners to have undertaken this work is in the course of converting the towers to residential use. Therefore a date of c. 1920-1925 is suggested for the non-historic windows. The sash openings are contemporary with the sash.

Historic window at the Beacon,  
typical for all three structures

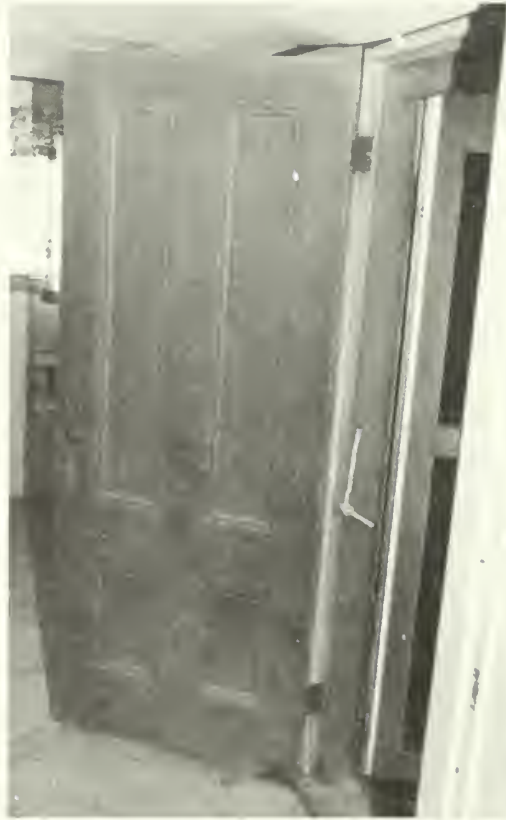
Figure 11

All three towers retain their original entrance doors (see Figure 11). The historic door for the Beacon was installed in the west wing which was demolished in 1983, but the door was removed and stored on the second floor. The four-panel doors are 2 feet-8 inches by 6 feet-7 and 1- $\frac{7}{8}$  inches thick. Panel mouldings are the same on all three doors (see Sheet 6). All three towers also retain the original door architraves and

Original entrance door at the Beacon

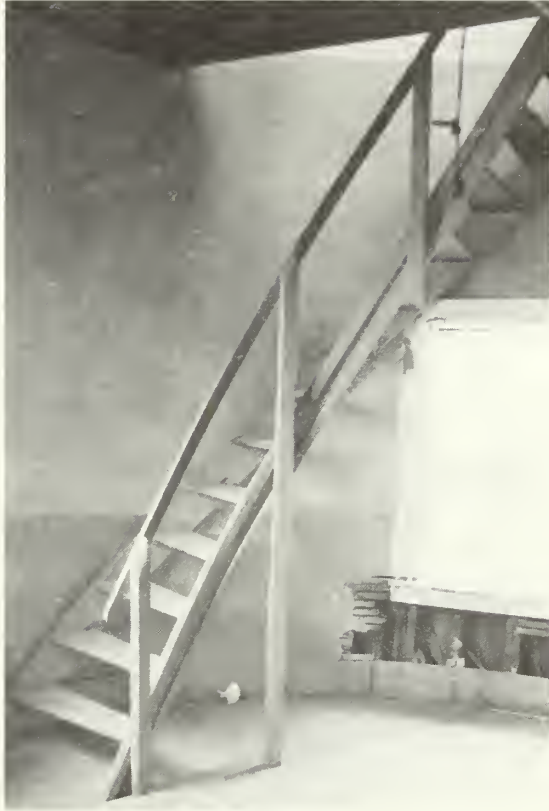
Figure 13  
Stairs at the Beacon

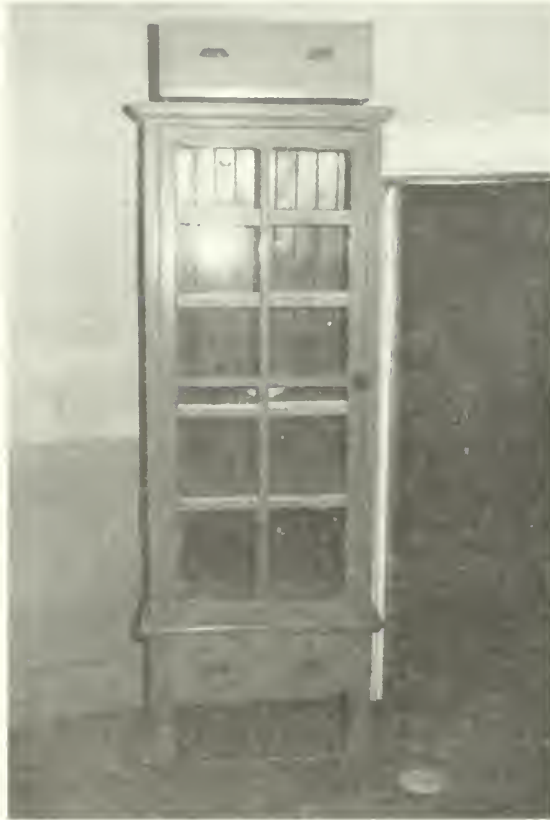
Figure 14

Built-in cabinet at the Beacon

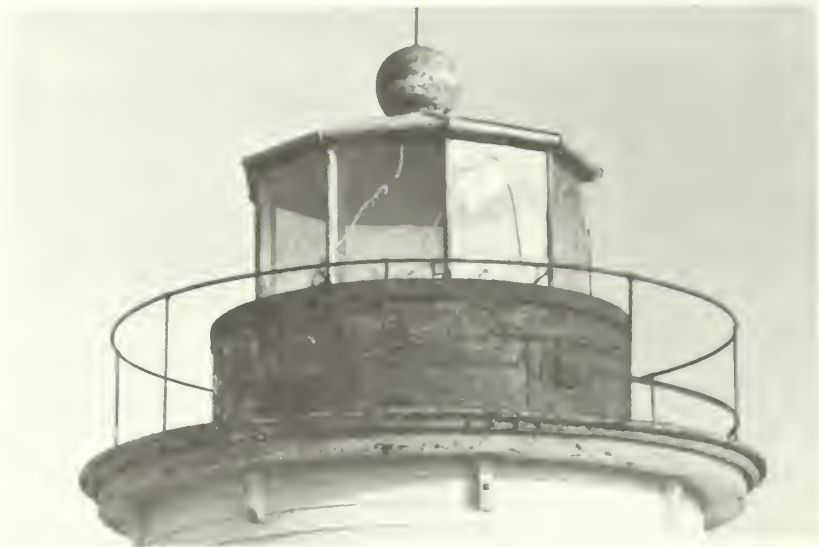
The walls of the lantern consist of a circular section 3 feet-3½ inches high (the parapet) and a nine-sided glazed area above. The interior finish of the parapet is 3½ inch beaded tongue and groove boards applied vertically to a system of curved nailers at floor level and at 2 feet-8 inches above. The nailers and the structure above are supported by 2 by 2½ inch wood studs, equally spaced around the perimeter both inside and out. The exterior wall is also made of 3½ inch tongue and groove boards. Wall thickness is 1 foot-2 inches. The tops of the boards are flush with the bottom of the cast iron sill at 3 feet-2¼ inches. Twenty-seven of the boards have been removed but are stored in the lantern. Five of these need to be replaced. There are four ventilation intake shafts evenly distributed around the perimeter of the parapet (see sheets 4 and 5). They provided fresh air with minimum draft for the combustion of the illuminating fuel. The ventilator ball on the roof was for exhaust of combustion gases.

Figure 15  
The lantern at the Beacon

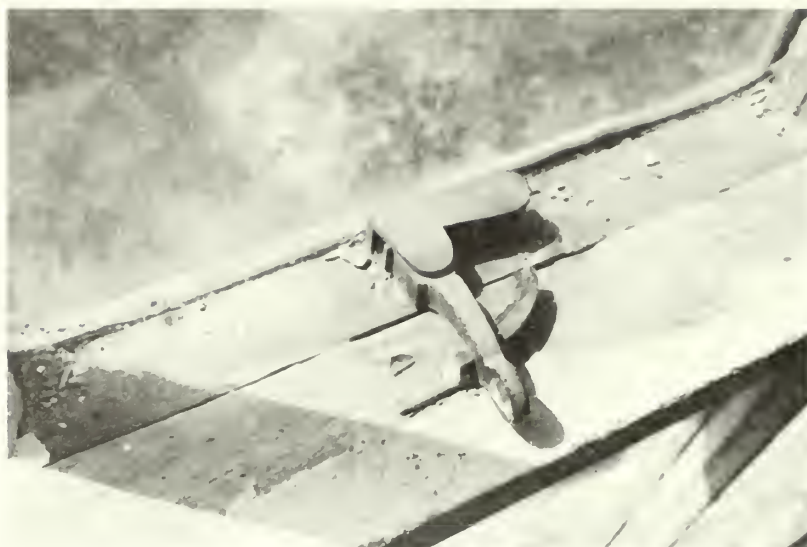
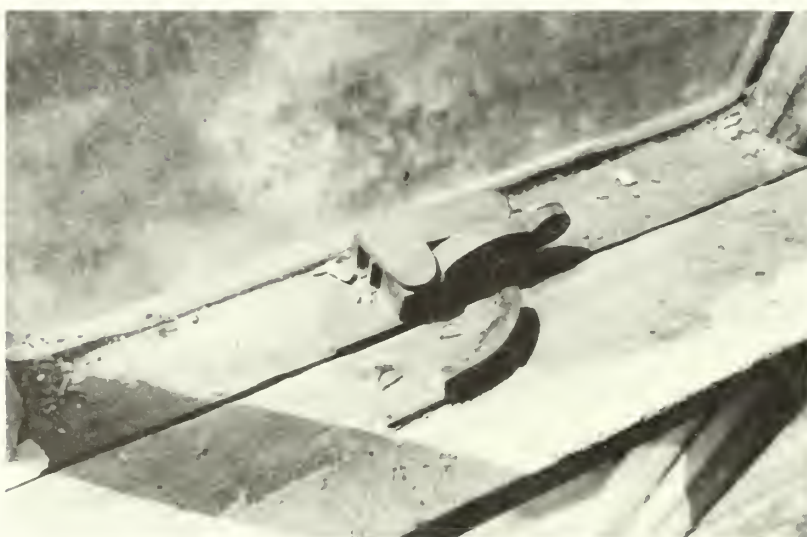
Figure 16

The historic windows are six-over-six single-hung sash. Sash fasteners are the helical spring type similar to Judd's patent as illustrated on page 77 in the Russell and Erwin Catalogue of American Hardware (see Figure 16). The sash pulleys are the standard iron sheaves mortised into the jambs. Historic pulleys have rectangular faceplates; the nonhistoric faceplates have rounded ends. Shutter hardware was found on the South Twin, but it is considered nonhistoric because there is no evidence of shutter hardware on the other towers and the historic photographs do not show shutters.

Historic sash lock (two views) in the North Twin  
Photograph by W. Howell June 1983
